## XX Front Derailleur Modification for Ibis Frames

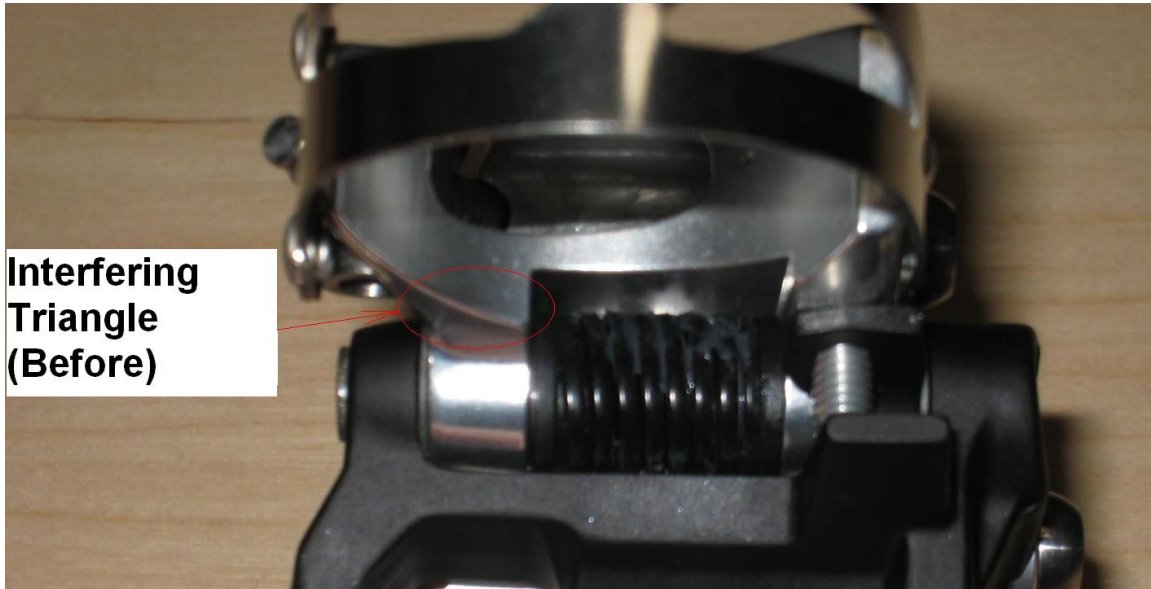
The SRAM XX front derailleur requires a slight modification to work properly on all carbon fiber Ibis mountain bike frames. On the back of the aluminum clamp body is a small triangle that hangs below the steel band clamp. This part needs to be removed in order for the derailleur to sit at the proper height. Ideally the outside edge of the front derailleur cage should have 2-3mm of clearance above the larger chainring. Removing the interfering triangle will allow the derailleur to sit low enough on the seat tube to maintain this gap.

To properly modify the derailleur, machine a radius into the interfering triangle. Only about 2 millimeters of material needs to be removed so that the clamp will clear the bulging carbon at the bottom of the front derailleur clamping area. Methods to achieve this radius include a simple hand file, light grinding with a Dremel tool, or, if available, an end mill. Once finished, the back of the clamp should look something like this:
